**Board Action Summary**  
**Real Estate Analysis Division**  
August 19, 2004

Underwriting appeals for:

Project No.: 113607

Project Name: Shiloh Village Apartments

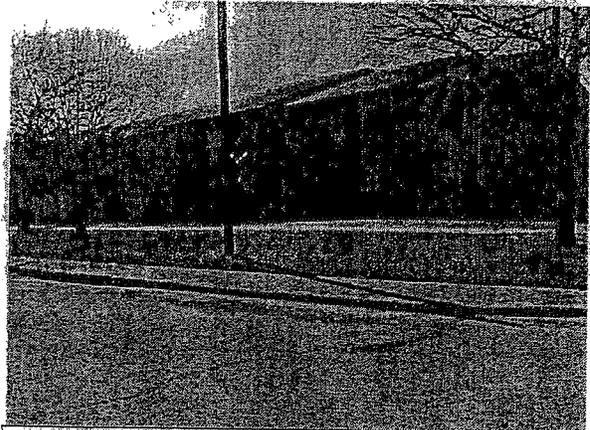
Photo #2: Front elevation of Building 1

Photo #2: Front elevation of Building 1

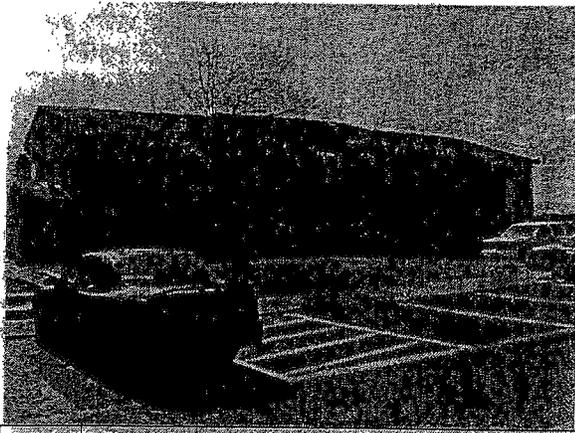
Photo #3: Front elevation of Building 4

Photo #3: Front elevation of Building 4

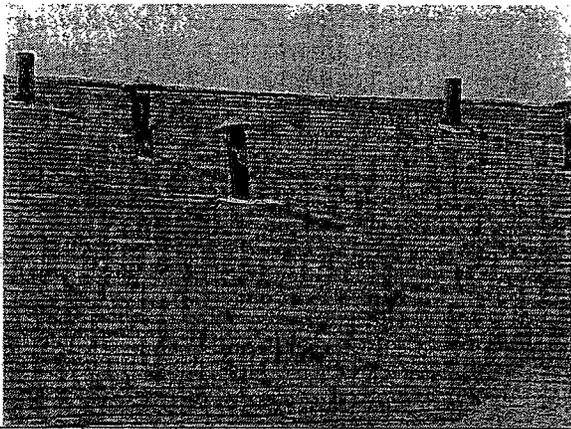
Photo #9: Roof overview

Photo #9: Roof overview

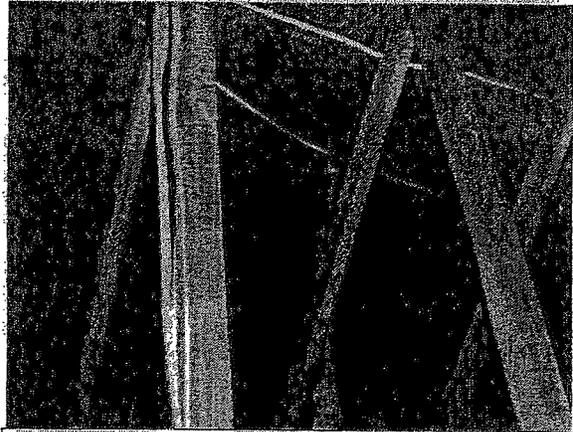
Photo #20: Structural components

Photo #20: Structural components

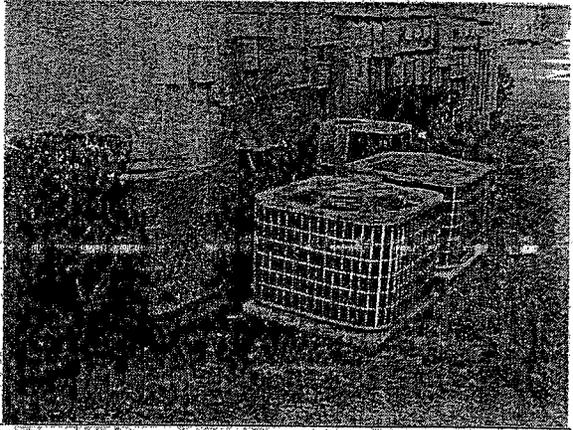
Photo #22: HVAC equipment

Photo #22: HVAC equipment

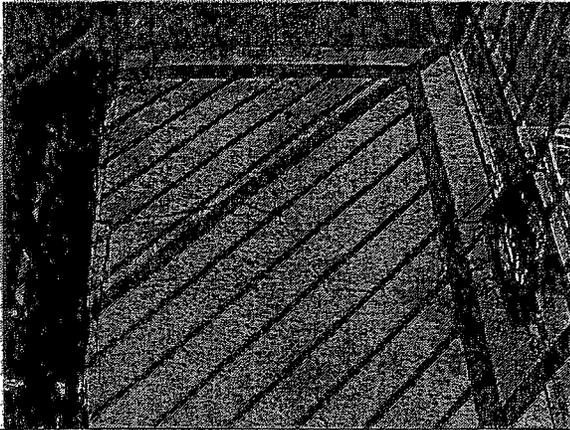
Photo #25: Damaged concrete stair landing

Photo #25: Damaged concrete stair landing

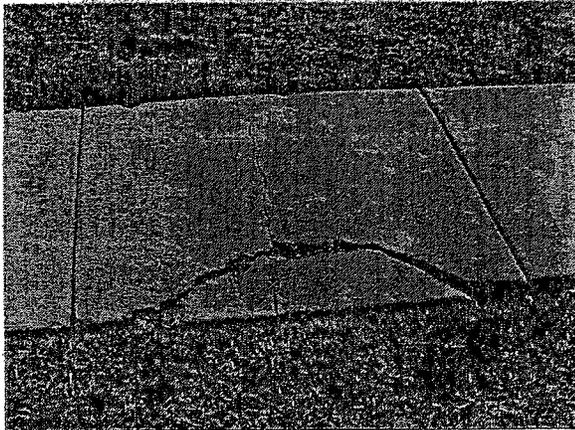
Photo #31: Damaged sidewalk

Photo #31: Damaged sidewalk

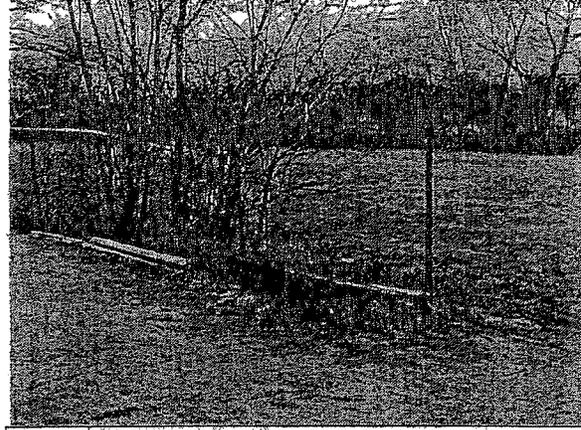
Photo #32: Damaged fencing

Photo #32: Damaged fencing

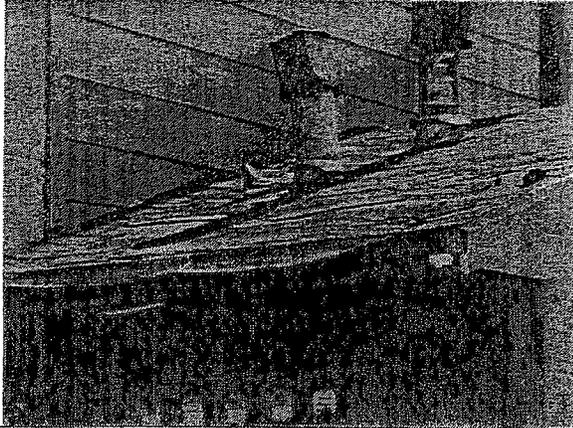
Photo #37:	Missing roofing shingles
------------	--------------------------

Photo #37:	Missing roofing shingles
------------	--------------------------

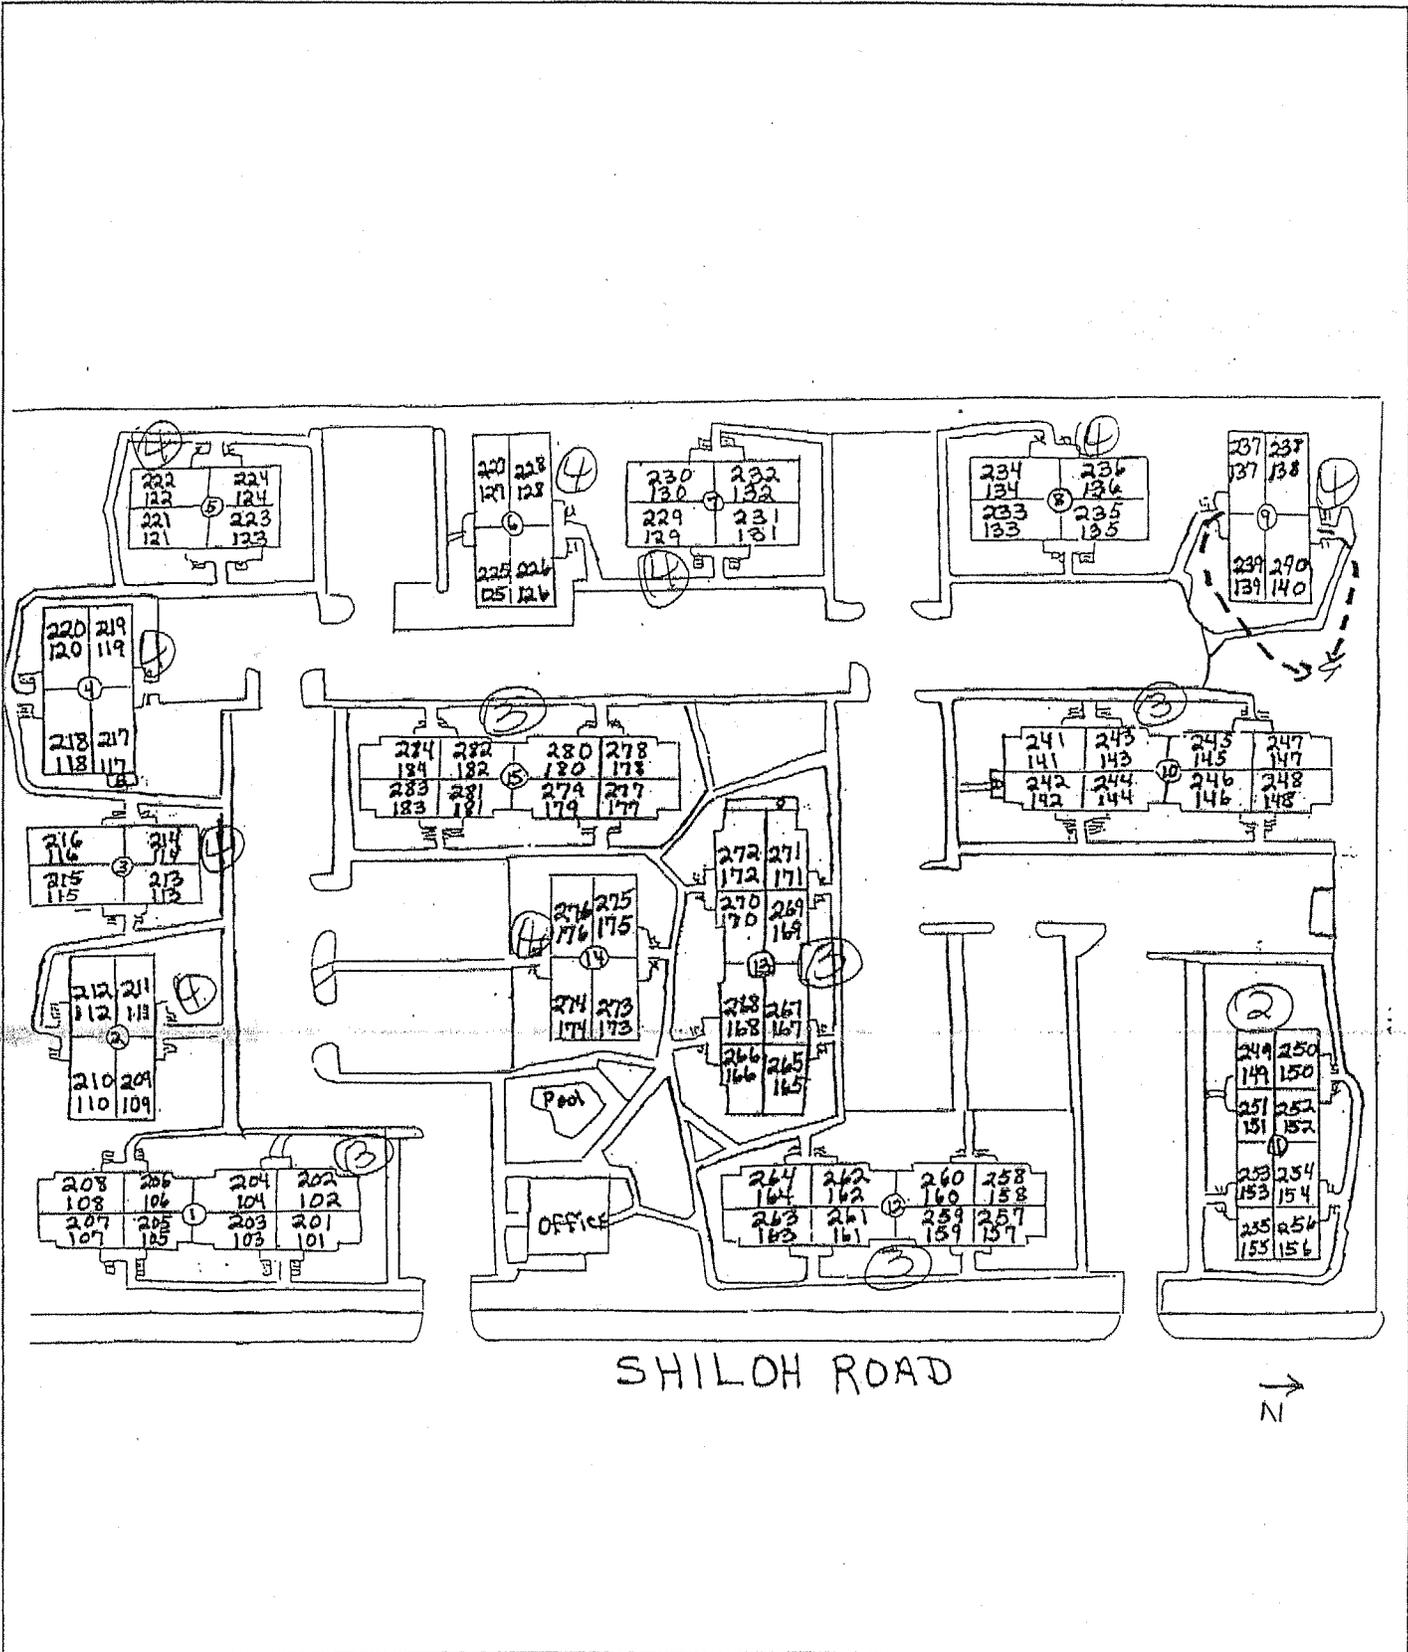
### Site Plan

Project Number: 113607  
 Project Name: Shiloh Village Apartments  
 Description: Site Plan  
 The north arrow indicator is an approximation of 0° North

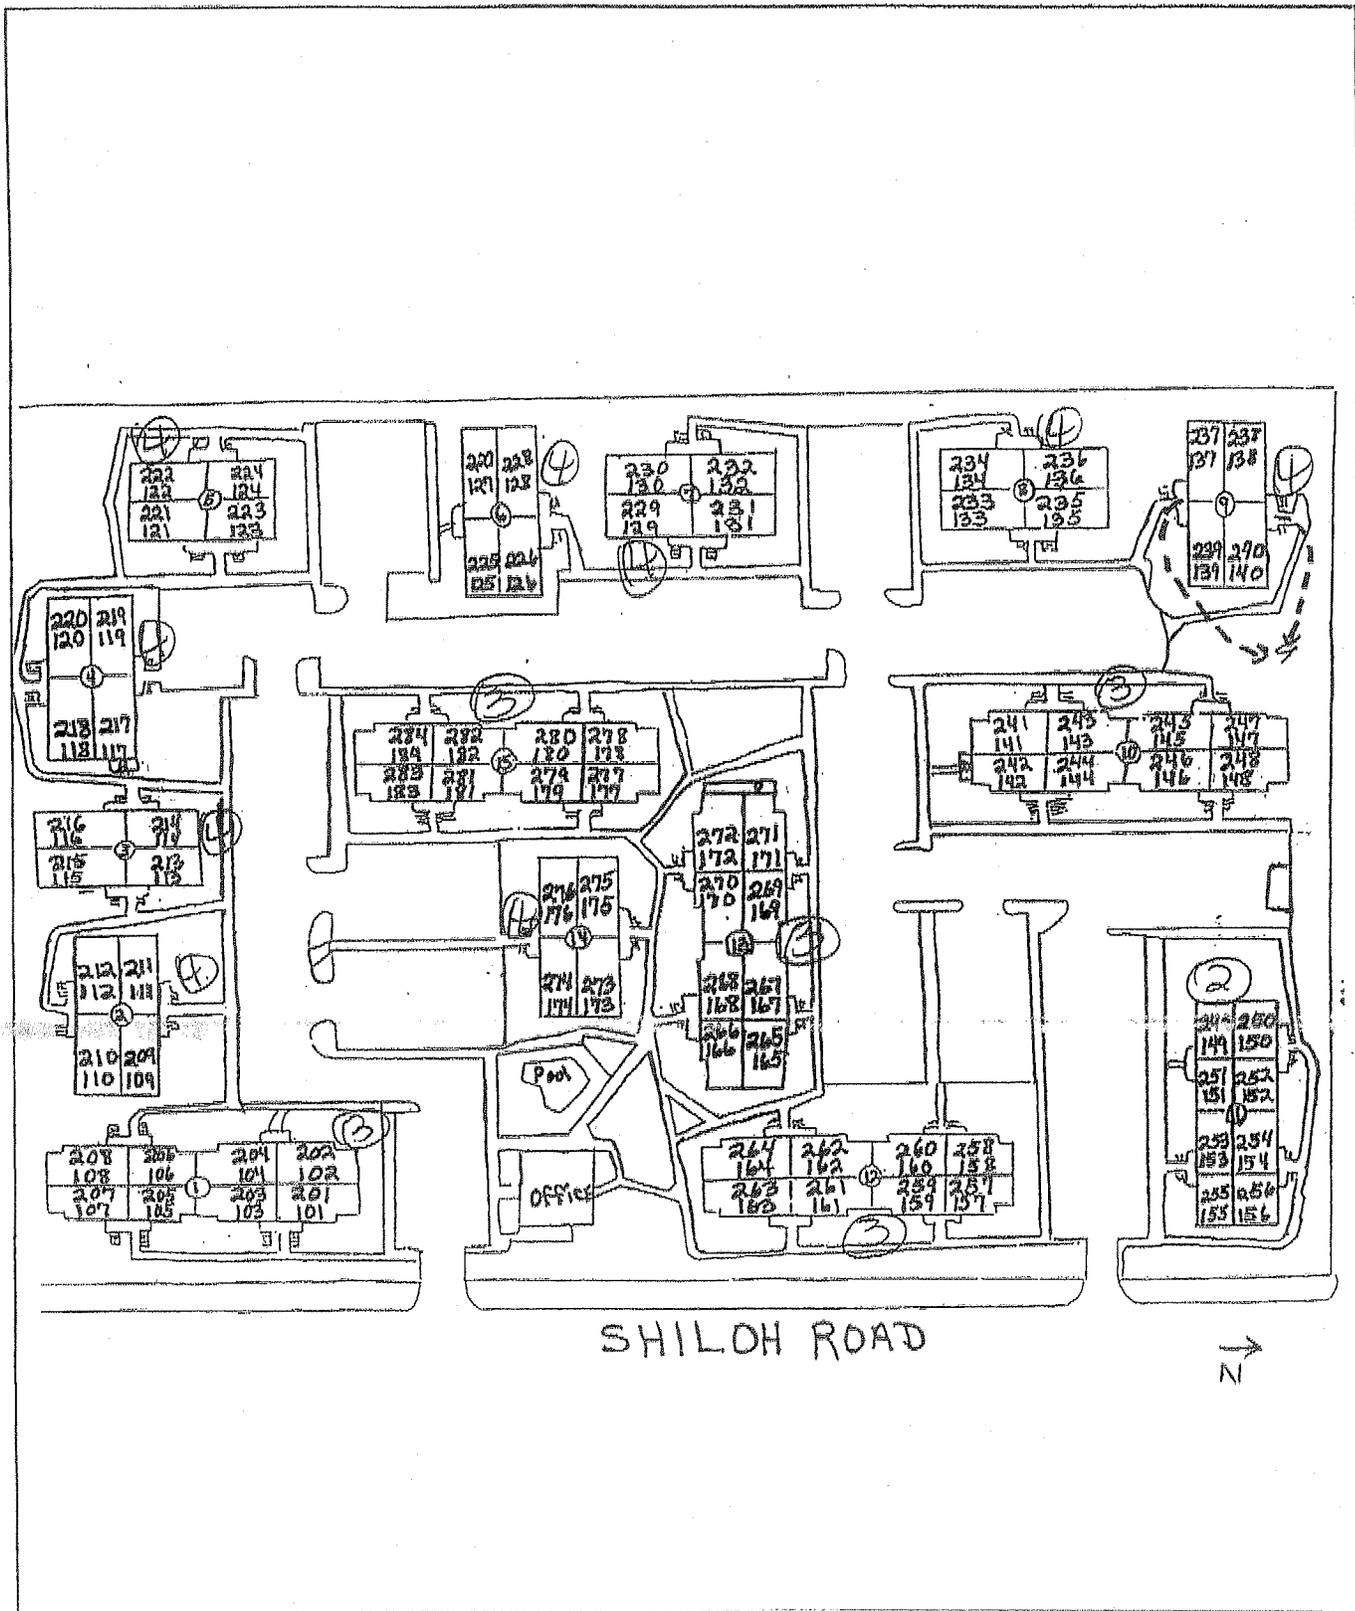
### Site Plan

Project Number: 120286  
 Project Name: Shiloh Village Apartments  
 Description: Site Plan  
 The north arrow indicator is an approximation of 0°North
